DETECTION OF STATOR WINDING INSULATION DEGRADATION

LOCATION: **OMAN**

ASSET: **CRITICAL SUBMERSIBLE PUMP**

690 V / 101.2 A / 90 KW / 50HZ

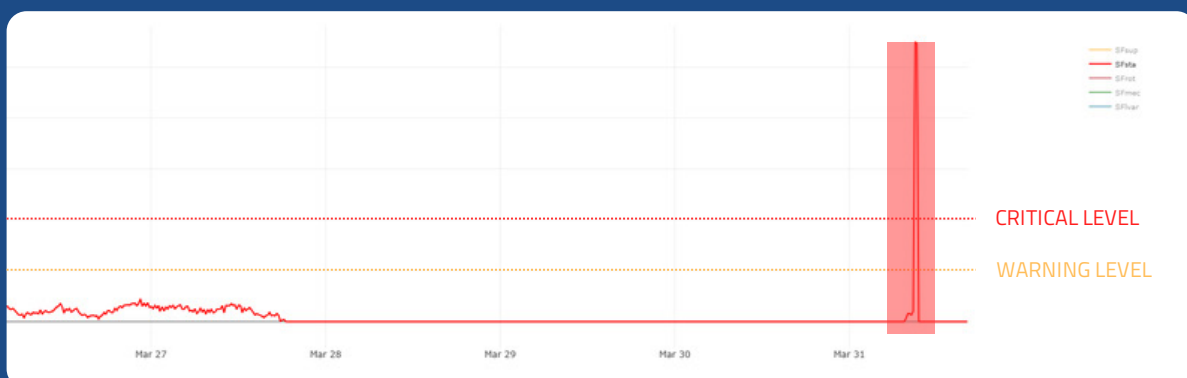
FIGURE 1 - TREND OF STATOR FAULT INDICATOR

During normal operation, PreditMot identified a sudden increase in the stator fault indicator (Figure 1), revealing a significant deviation from the motor's baseline electrical signature. The abnormal behaviour was automatically classified as a critical event, generating an alarm and notifying the maintenance team. The detected pattern was consistent with insulation degradation developing within the stator winding.

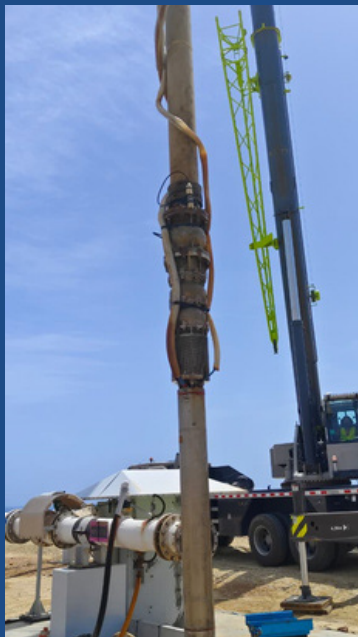
FIGURE 2 - PUMP DETAILED INSPECTION:
A) PUMP BEING REMOVED FOR DETAILED INSPECTION
B) INSULATION RESISTANCE TEST SHOWING 0 MOHM

Based on findings and inspection results, the client immediately initiated the required maintenance actions. The pump was taken out of service in a controlled manner, allowing proper inspection and corrective work without risking further damage or unexpected catastrophic failure (Figure 2) .

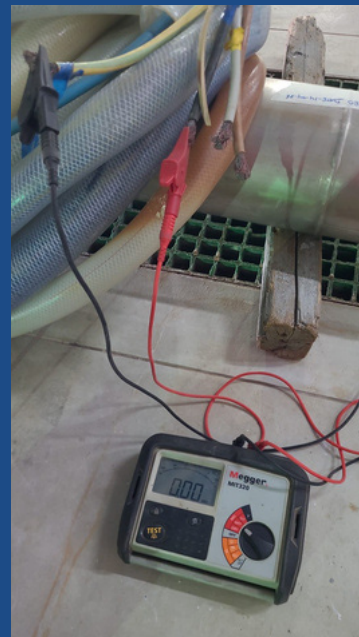
B)

Following the alarm, the maintenance team performed on-site electrical validation tests. Insulation resistance measurements confirmed severe insulation degradation, with results approaching 0 MΩ, validating the diagnosis generated by PreditMot. Subsequent inspection of the motor revealed clear evidence of internal insulation breakdown, confirming the presence of a developing stator winding failure. A detailed inspection of the motor further revealed clear signs of internal insulation breakdown.
